## **GLENDALE CHANNEL GRAVEL ASSESSMENT**

### **Introduction & General Overview**

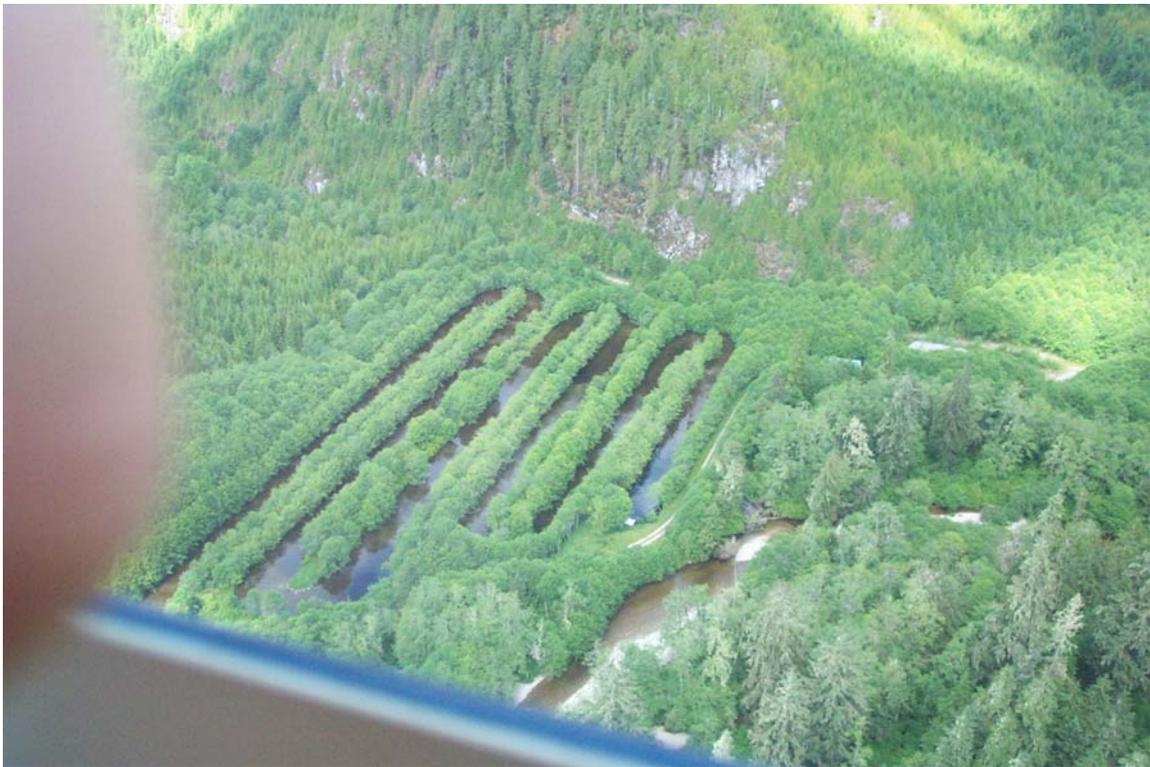
Photo 1

The first impression from both the air and the ground is that the channel is overgrown with riparian vegetative growth, mostly alders which cover approximately 50 % of the gravel beds. In some cases this growth extends half way across the 15 meter wide beds. (Photos 1 & 6)

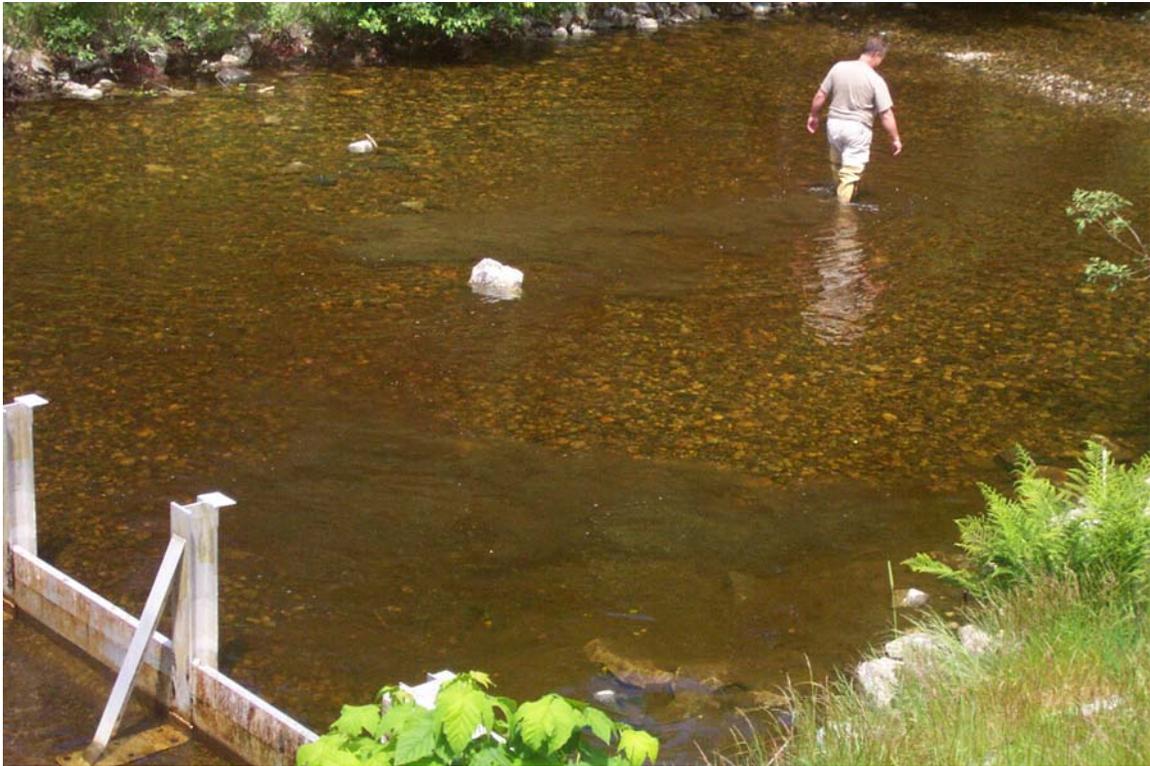
Photo 2

Merely walking on the gravel created large plumes of brown organic matter. This occurred throughout the channel, completely obscuring the gravel in only a few cm. of water.

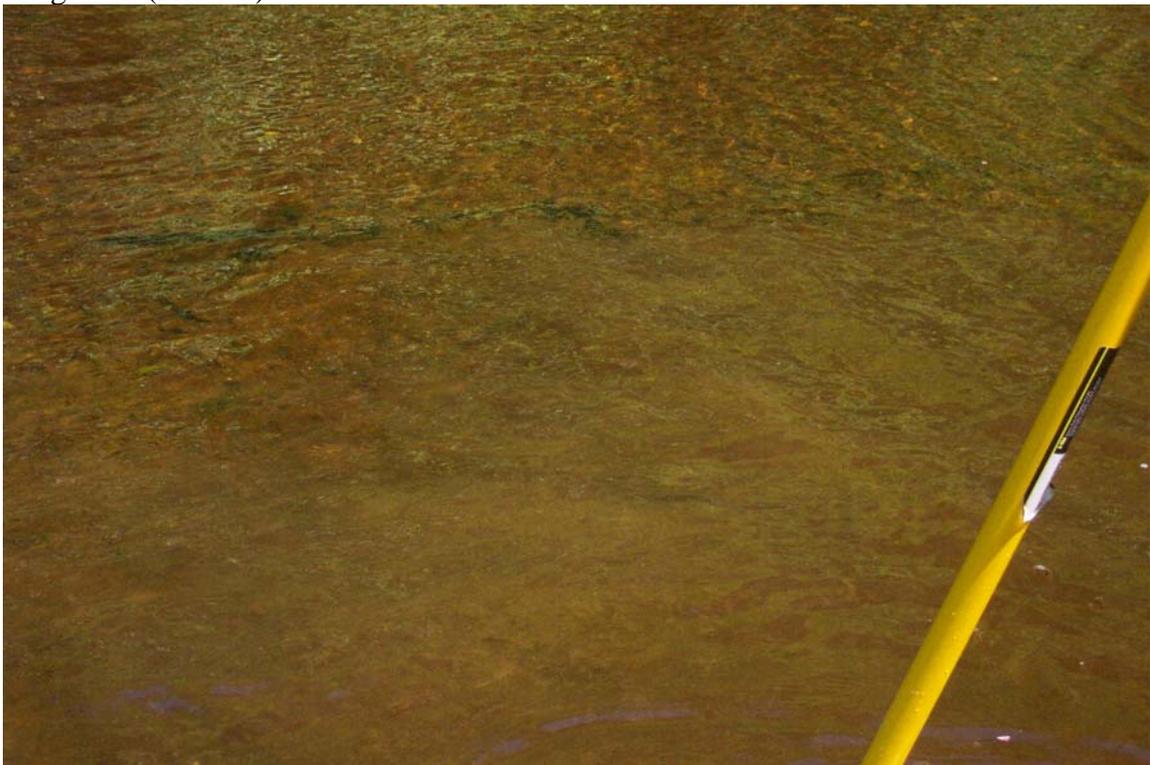
Photo 3

This material, which appears to be partially decomposed organic matter became progressively worse down each leg (except the last leg), in some cases covering 90 % of the gravel. (Photo 3)

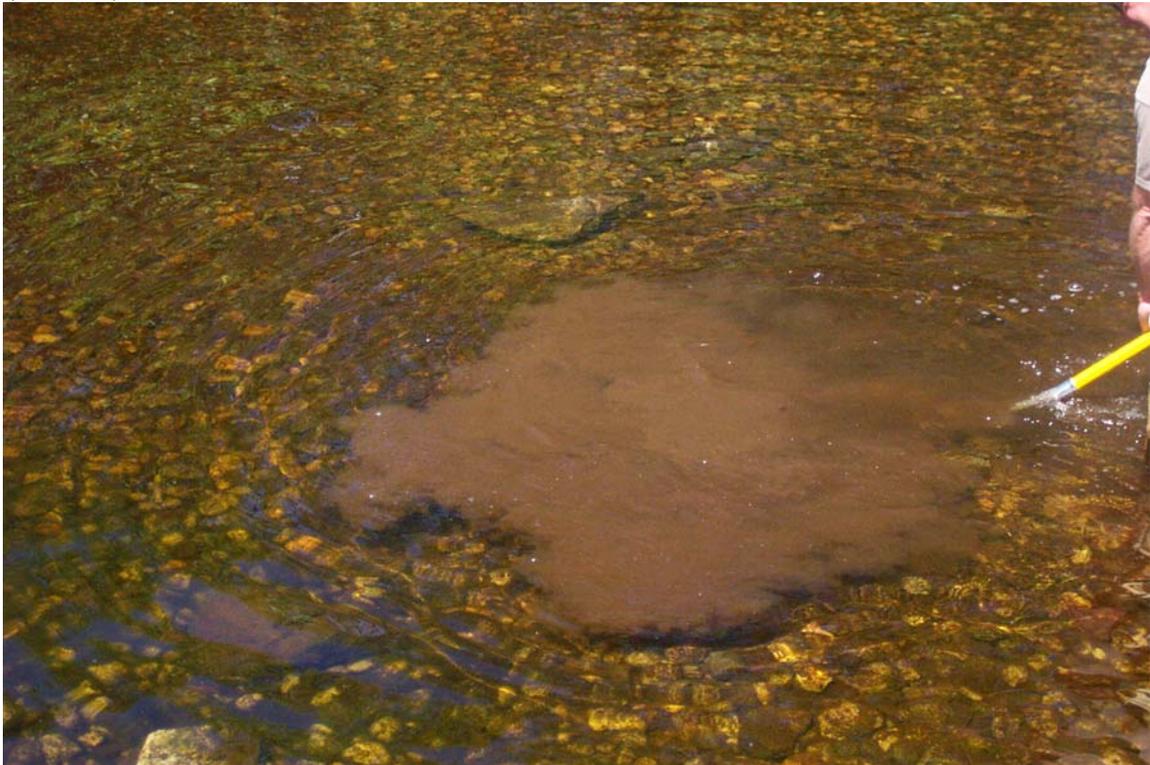
Photo 4

During each excavation, large amounts of brown, powdery material was flushed out and this was encountered from the gravel surface to the where actual silt was encountered.

(Photo 4)

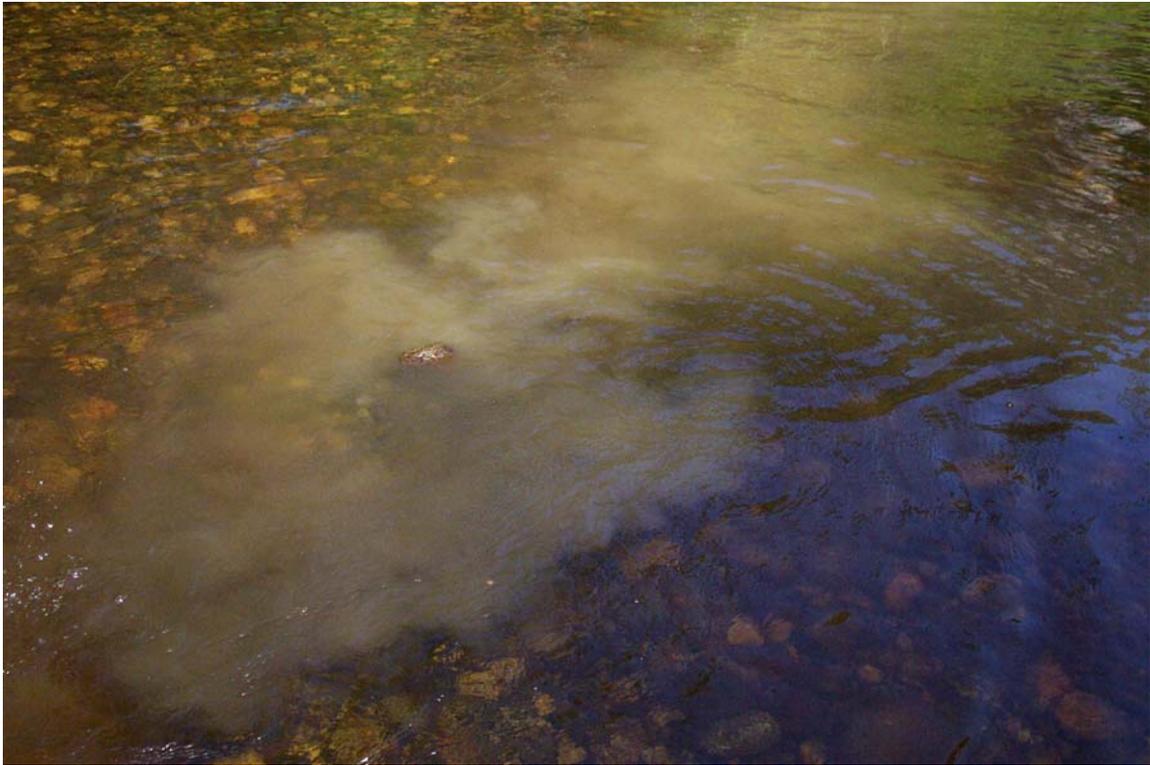
Photo 5

Once the actual silt was hit, the color changed from a dark brown to grey. (Photo 5 below)

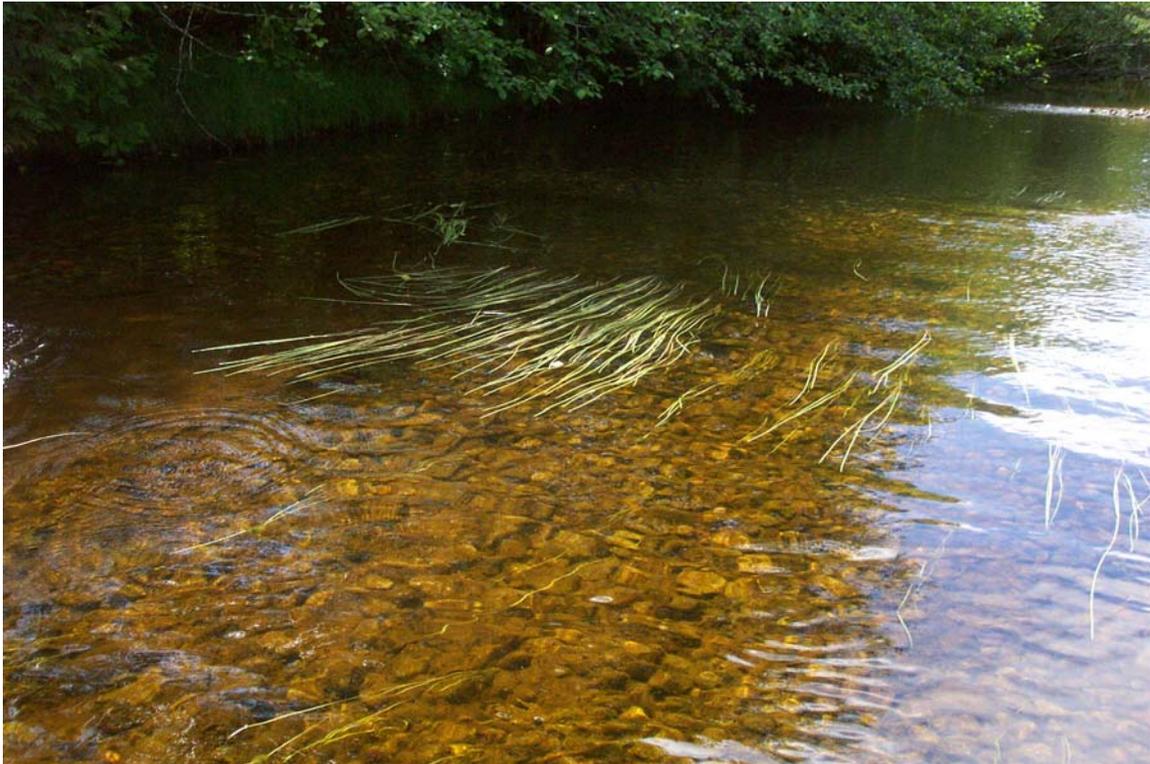
Photo 6

As mentioned in the introduction, mostly alder branches hang over the beds on both banks. This growth, while very beneficial for shade which assists in keeping the water cool during the spawning period, especially, is an impediment when maintenance of the channel beds is necessary. The value of a healthy riparian zone along natural streambeds is ideal, but excessive vegetation along the bank of an engineered channel with a very low gradient and with no ability to regenerate gravel or self-clean during freshets, is problematic on two fronts. Leaf litter, etc., drops into the channel and becomes part of the organic mass which will consume oxygen during decomposition, especially coupled with large amounts of algal material. This situation is exacerbated even if the fall leaf loss does not coincide with the spawning period. Alder leaves are heavy and sink onto the gravel where they decompose. So, coupled with a high background organics, the total amount from all sources will reduce available dissolved oxygen (DO) in the gravel column.
