GLENDALE CHANNEL CLEANING REPORT – 2007

Report

Redfish Services

July 22, 2007

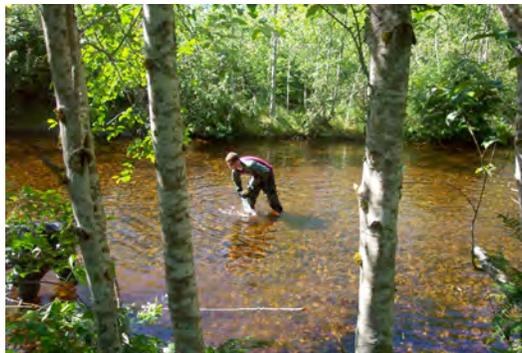
Since cobble removal from the beds would not be possible due to poor visibility once cleaning started, two passes down the full length of each channel leg was done. (Photo 1)

Photo 1 – Removing large rocks from beds

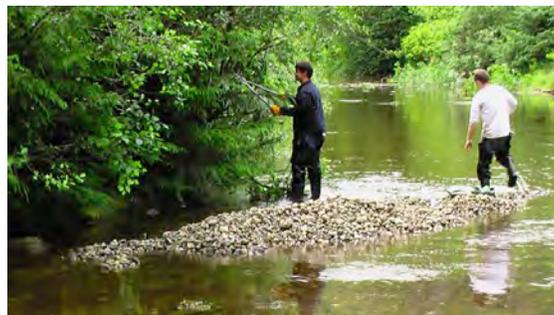
Another, two-man crew began the limbing of the lower riparian growth to allow the excavator operator to see well enough to clean up to the bed edges. All limbs were placed on the berms. (Photo 2)

Photo 2 – Limbing lower branches

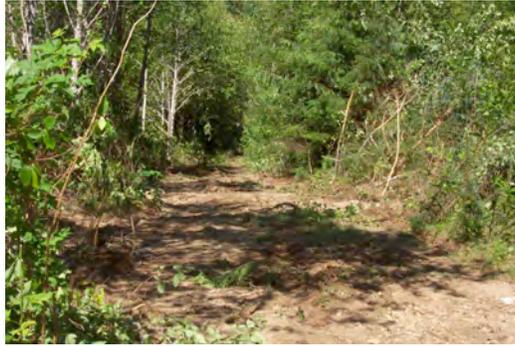
Photo 3 – Access road

Nearly 20 years of alder growth needed to be removed. Access points were punched in - one at the bottom of Leg 3, the other at the bottom of Leg 6. (Photos 3 and 4)

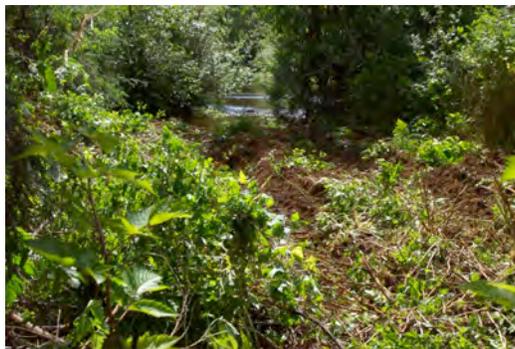
Photo 4 – Entry – exit to the channel leg

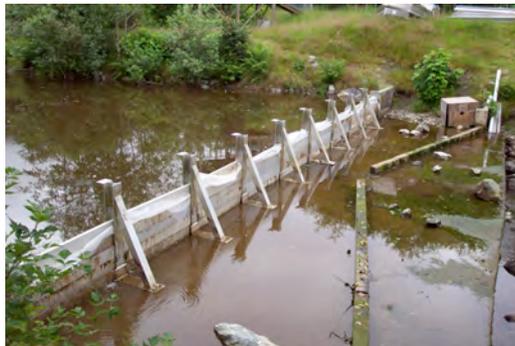
With flows reduced, stop logs with a plastic lining were placed at the channel outlet to retain any turbid water. (Photo 5)

Photo 5 – Outlet plastic-lined dam

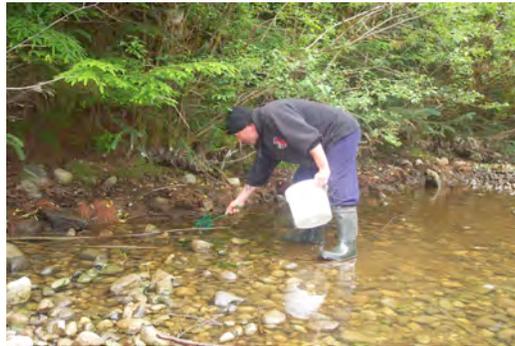
A retaining, plastic-lined gravel dam was made, pump intake hoses placed and the containment area behind the dam was pumped out. Fish salvage was conducted in this area. (Photos 6 and 7)

Photo 6 – Fish Salvage

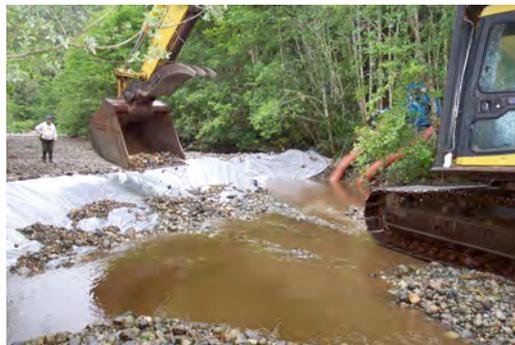
Photo 7 – Gravel plastic lined dam at first pumping station

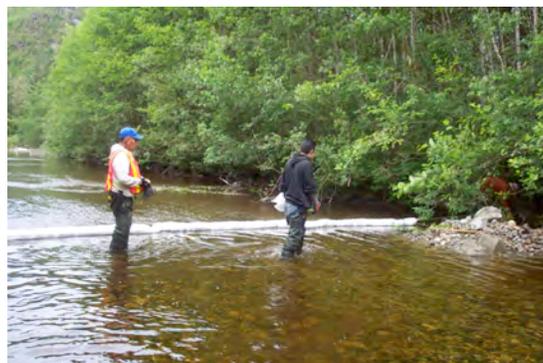
Two spill containment booms were placed in the channel legs in the event of a hydraulic oil spill. (Photo 8)

Photo 8 – Spill containment boom

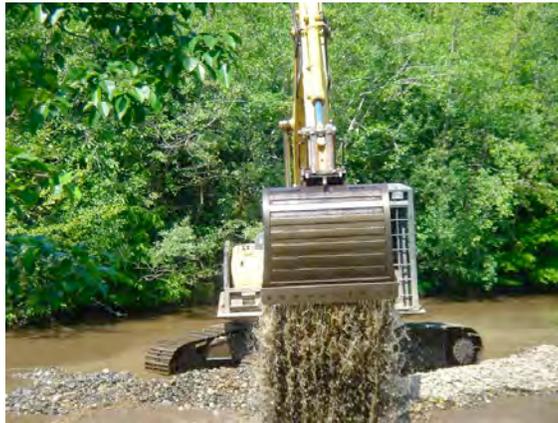
The scoop and recast cleaning method, as described in the Gravel Assessment Report, was used. (Photo 9) To briefly recap: Using the water and current to flush out the silt and organic matter, including large numbers of dead eggs, the excavator scooped up and recast the gravel over a broad area until the gravel appeared clean and the bulk of the brown organic

Photo 9 – Scoop and recast cleaning method

matter was flushed out. This process was repeated three or four times in each area before the excavator was moved a short distance downstream. As cleaning continued, a progressively deeper layer of organic goop accumulated behind the machine. In order to move this material, it was necessary for the excavator to repeatedly rotate and plunge the bucket up and down vigorously, forcing this sludge downstream. During this necessary process, many small branches, extending well over the channel beds were broken off. These branches found their way to the pump intake screens and plugged them up, necessitating several cleanings per day. There was also a continual concern of the sharp ends of the broken limbs rupturing the hydraulic line hoses. (Photos 10 and 11)

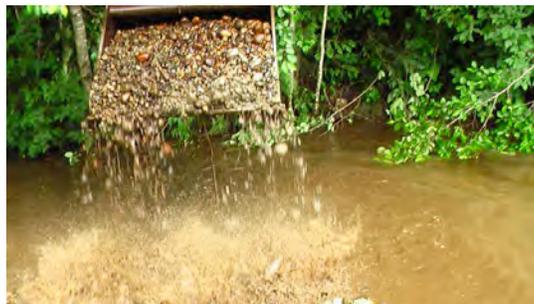
Photo 10 – Cleaning close to the berms

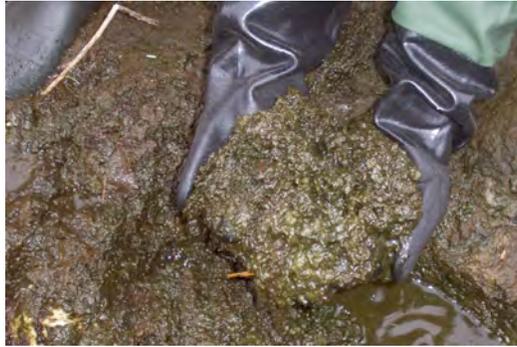
Photo 11 – Accumulated organic goop

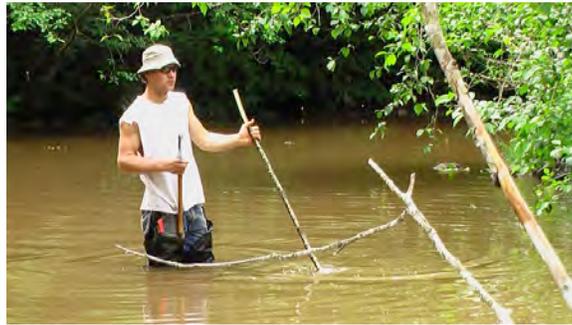
It was necessary to mark out and flag all the holding pools in the channel legs. (Photo 12) Once cleaning started, it was important to find them to prevent the excavator from backing into one. The ‘planned’ drawings in the authors’ possession did not reflect the ‘as-built’ locations.

Photo 12 - Marking the deep pools

Pool Removal – Holding pools were ill-conceived ideas that have more disadvantages than benefits. This is now understood and these pools have been filled in and the area used to increase spawning area. The Horsefly Channel is one example. It is recommended that this be done at Glendale Channel, especially since a stored gravel source is available on site. In the mean time, when another cleaning takes place, the use of small trash pumps would remove some of the deleterious matter. This process may not be possible at all six pool locations.

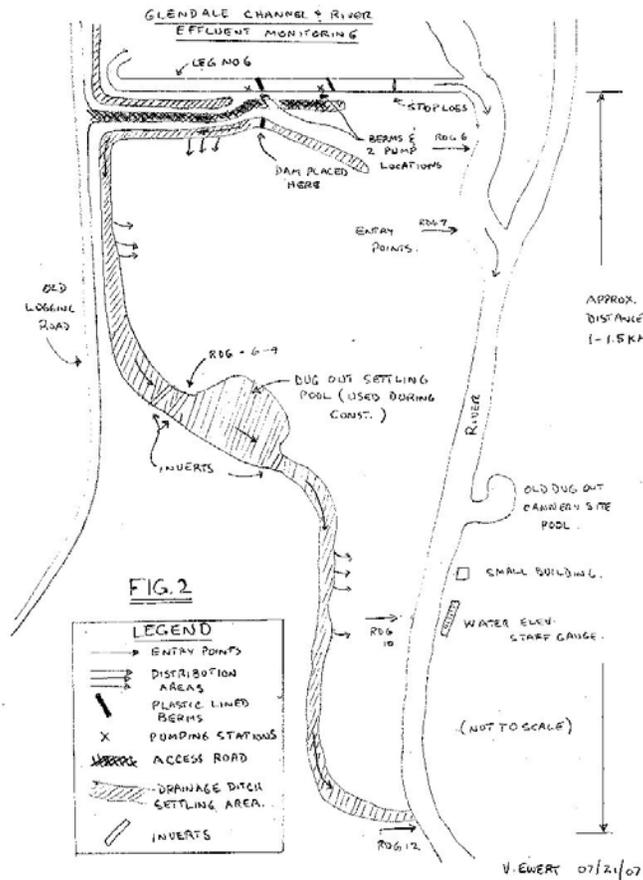
Fig. 2

After one and a half days of cleaning and pumping at the first location, a small amount of organic laden water, estimated to be .5 cfs (.01 cu/m/s), was observed entering the river at two locations nearest to the channel outflow area. (Fig. 2) No other entry points were discovered over a downstream distance estimated to be 1.5 km.

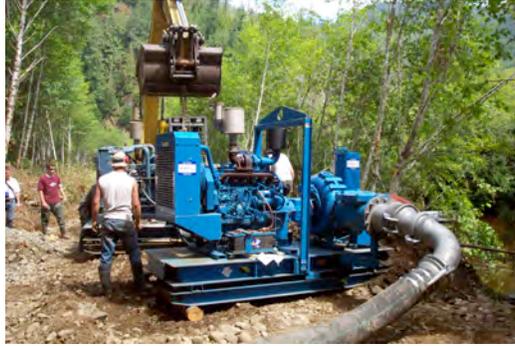
Cleaning was stopped and an alternate area was searched for. An extensive network of drainage ditches and settling areas was discovered. (Photos 13 and 14)

Photo 13 – Second pumping station

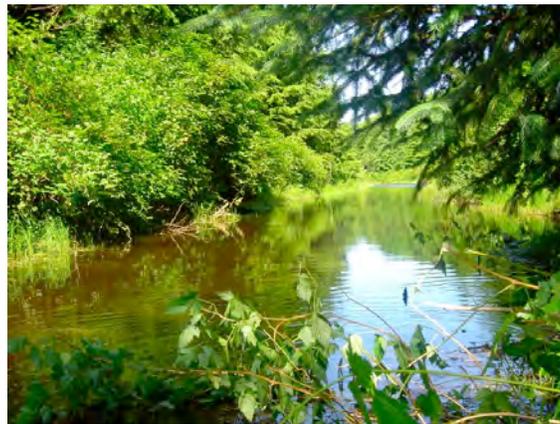
Photo 14 – Drainage ditch

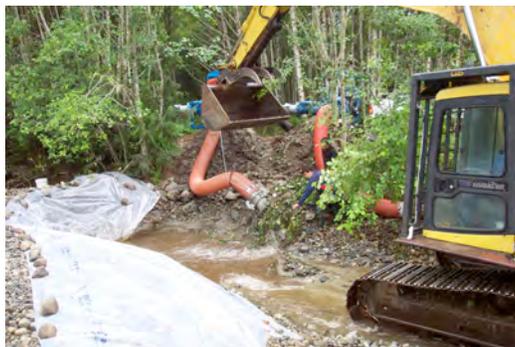
Photo 15 - Plastic-lined dam and second pumping station – Cleaning the intake screens

The second station also had a plastic-lined dam below the pumps and this gave two holding areas for dirty water. (Photo 15) It was observed that since only the top sides of the dams were plastic-covered, once pumping started again (one pump shut down at a time) after the cleaning of the screens, the dirty water flowed back through the gravel dams and was pumped out. This ensured that while servicing the screens, this accumulated dirty water could effectively be removed.

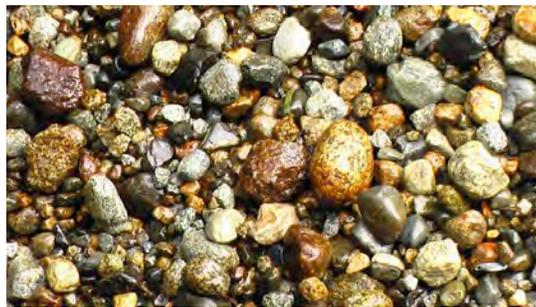
With the exception of Leg 2, after the cleaning/remixing was done, the gravel composition had the appearance and texture of a well-mixed, clean, fluffy gravel bed. Leg 2 appeared visually to lack the same amount of smaller particles as the other legs. The volume of gravel expanded visibly due to the loose nature of the medium. (Photos 16 and 17)

Photo 16 – Cleaned gravel with a good mix

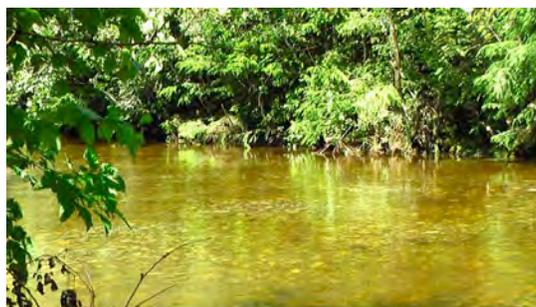
Photo 17 – Cleaned gravel beds

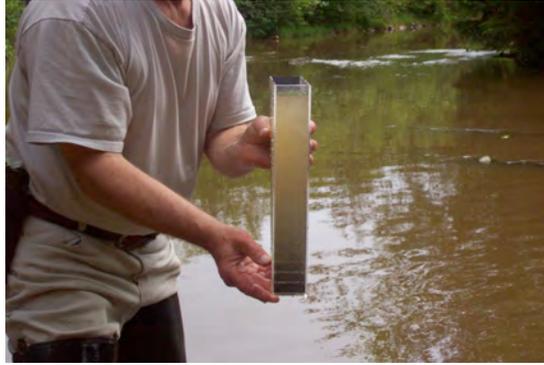
Sediment wedge readings, using the Triton Sediment Wedge showed, as expected, that the lowest -0- (dirtiest) readings were close to the cleaning process with readings progressively higher over distance. (Photos 18 and 19)

Photo 18 – Sediment wedge readings

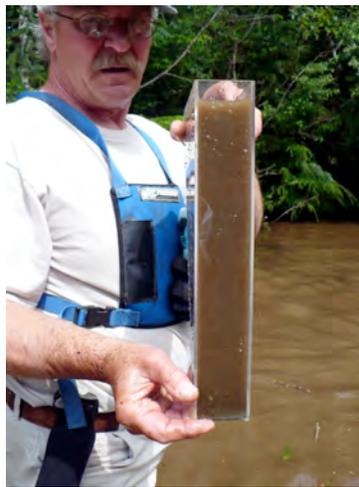
Photo 19 – Sediment wedge reading
