GLENDALE CHANNEL CLEANING REPORT – 2007

Report

Redfish Services

July 22, 2007

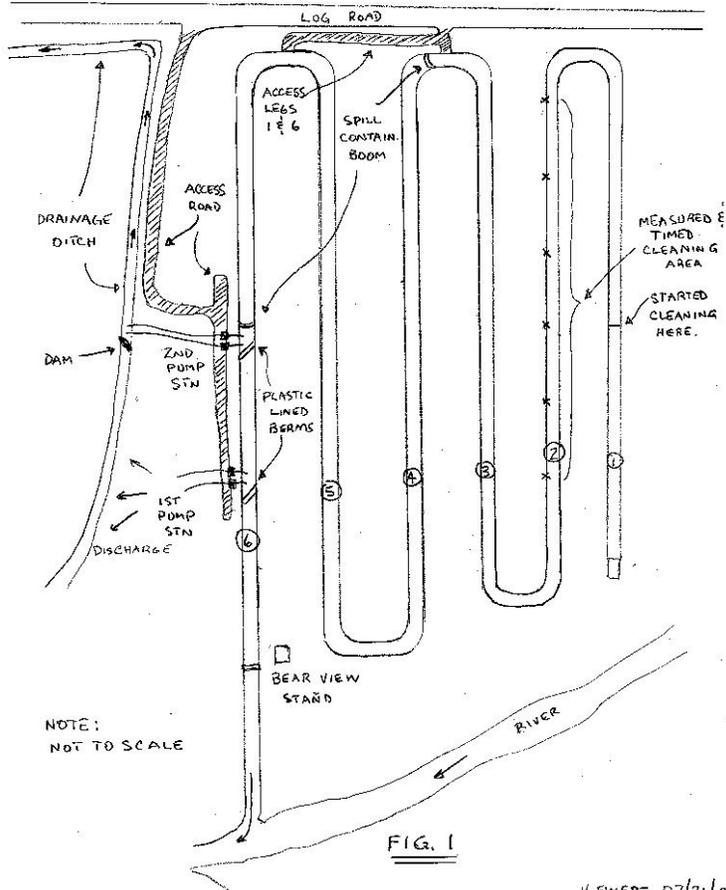
GLENDALE CHANNEL GRAVEL
CLEANING

All of the pumping gear was placed at the first pumping location. (Fig. 1)

To encourage flows in the desired direction, away from the river, a dam was put in a ditch adjacent to the cleared roadway to Station No. 1. (Fig. 2) This second location, Photo 15, approximately one-half way down Leg 6, (Fig. 1) proved superior with the vast majority of flow going down the ditches and into the settling areas. It overflowed at various points onto the forest floor. A total reentry amount of approximately 1 cfs, (.021 cu/m/s), or less than 2.5 % of the volume pumped was noted in four locations over the monitored area. A metered stick was used to ensure no backup of levels occurred. Sediment wedge readings are covered in the summary section.

The entry points (Fig. 1) allowed for the entry and exit of the excavator for daily servicing and fuelling. No fuelling was done in the channel. Cleaned areas were not traveled on by the machine once cleaned. Travel in and out was restricted to the nearest downstream entry point as cleaning progressed.
